## PHOTO INTERPRETATION NOTE

## CONSTRUCTION RESUMED ON KU-CHI-KU RAILROAD, CHINA

TCS-22577/70
JANUARY 1971
COPY NO 118
2 PAGES
PIN-114/70

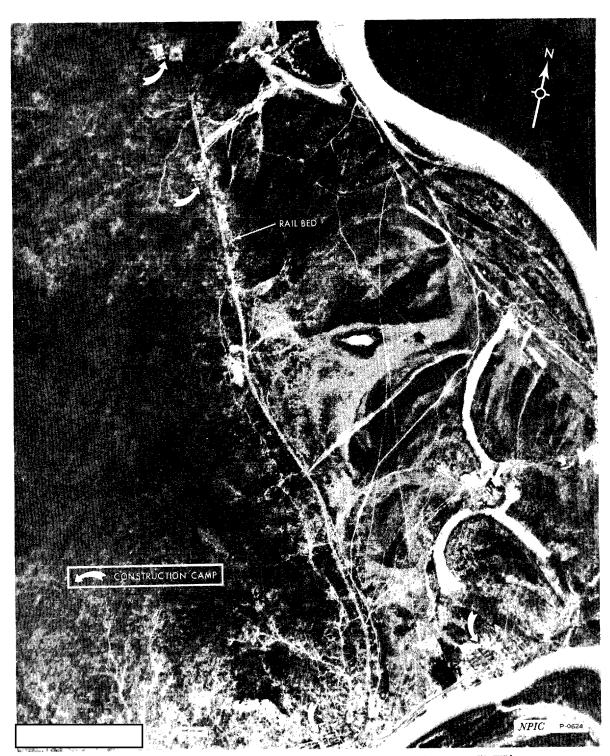
FIGURE 2. KU-CHI-KU RAILROAD CONSTRUCTION, CHINA

1. Construction on the Ku-chi-ku railroad has been resumed since (Figure 1). New railway construction, scarring, and associated 25X1D construction camps were observed on photography of for a distance of approximately 50 nautical miles (nm) from the railhead observed in \_\_\_\_\_at 52-42-00N 123-35-10E (Figure 2). The new 25X1D construction extends to 53-01-20N 122-29-30E, approximately 23 nm south-
